# Energy Project Villa – Main Report

The Energy Project Villa report consists of two parts, Main Report as well as a Report of Appendices. In addition to this a separate report with modelling of energy consumption has been made by DTU (R-102).

In Energy project Villa the cost saving effect of renovating a typical existing villa built before 1950 has been documented. In this way the project can be regarded as a contribution to the documentation of the potential energy savings in the existing building stock.

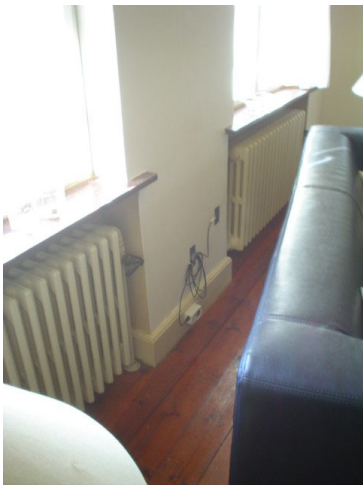
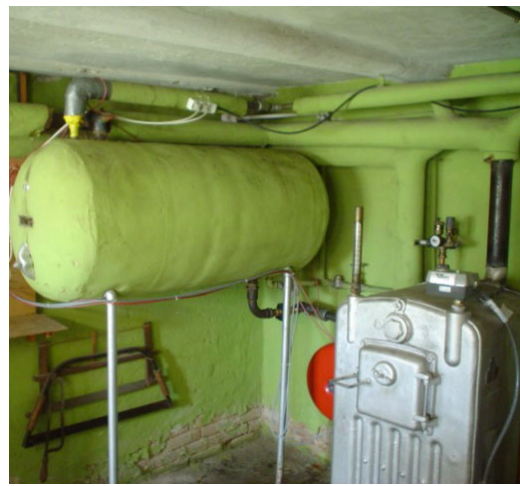
Room heating was originally provided by old cast iron heaters with manually operated on/off valves. The room heating system was water-based, buoyancy driven, and two-stringed. Domestic Hot Water (DHW) was stored in a 200 l horizontal hot water tank placed in the unheated basement. The heating was produced by an old un-insulated cast iron boiler with an oil burner placed in the basement. See pictures below.

As the heating system was buoyancy driven, pipe thicknesses were between 3/4"-2 1/2". The general insulation thickness of the pipes was around 30 mm.

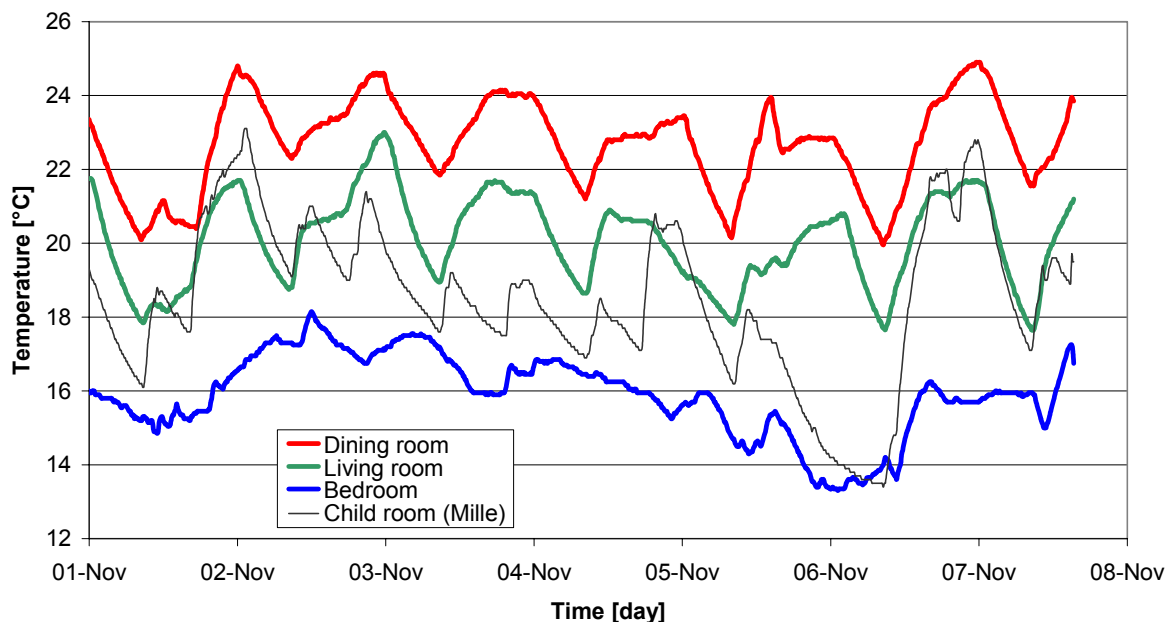
Figure 5.1 Room temperatures in the Villa before renovation. November 1-7 2004. Typical winter week.

Figure 5.1 shows a typical example of how the temperatures vary throughout the day. Especially in the living room and dining room, the maximum temperatures occur around midnight and minimum temperatures early in the morning. This is probably due to the fact that the existing cast iron radiators had manually controlled on/off valves only. If the valves are left on while the residents are not at home, the temperatures get too high. Therefore, the residents leave the radiators off while not at home. As the heating system and the building constructions in the villa are thermally heavy/slow, it typically takes 1-2 hours before the temperatures are at comfort level again.

It appears from Figure 5.1 that especially in the bedroom, but also in the children's rooms, temperatures have been extremely low. One explanation might be the daily airing routines of the residents. Every morning they open windows and ventilate all bedrooms thoroughly - these can possibly have been left open for longer periods. Another explanation might simply be that the residents prefer very low temperatures in their bedrooms and thus more or less keep them unheated.

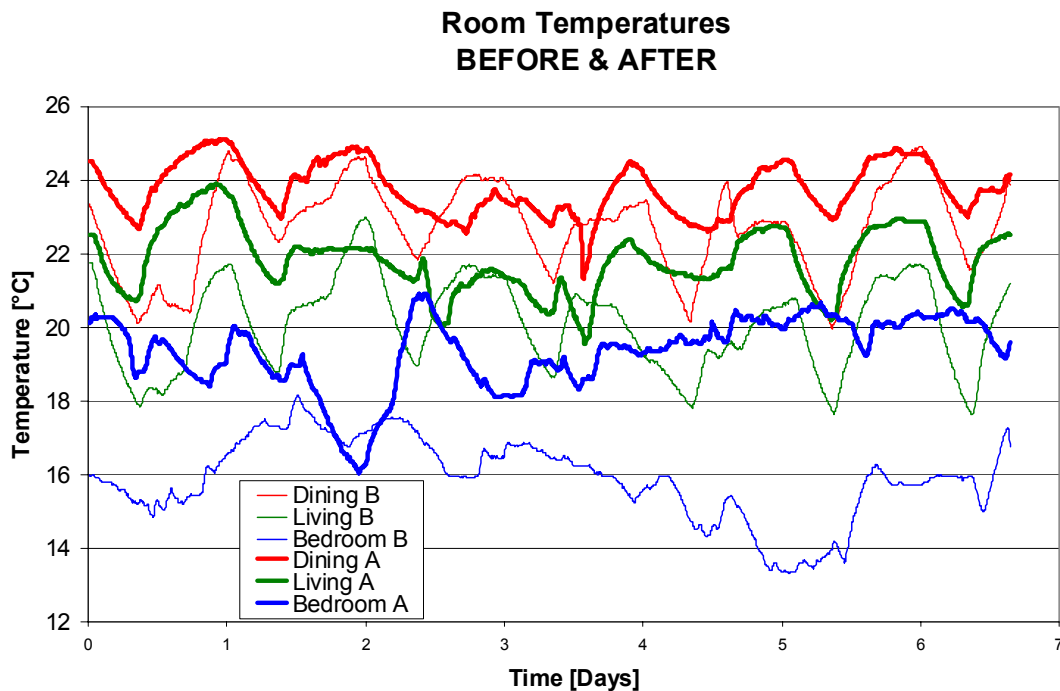
**Figure 6.1: Room temperatures in the Villa after renovation. December 4-11, 2004.  
B indicates before renovation and A indicates after renovation.**

Figure 6.1 compares typical examples of how the temperatures vary during the day before and after the renovation.
